# MINOS+ Status Report

Xinjie Qiu  
All Experimenters' Meetings  
October 28, 2013

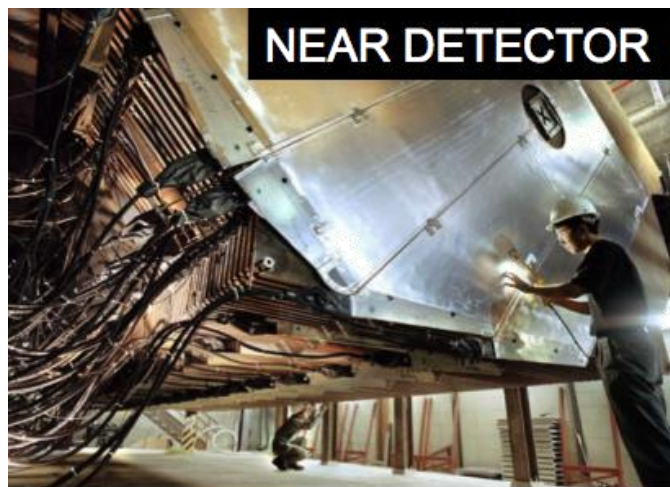
- LCW (Low Conductivity Water Systems) loop and ND coil magnet
  - Refilling the LCW expansion tank
  - Resistivity in the LCW loop over the last 6 months is dropping

- Should replace the DI bottle filter and other filters in the LCW loop
  - Arrange this in the next access of more than a day
- New serial server installed

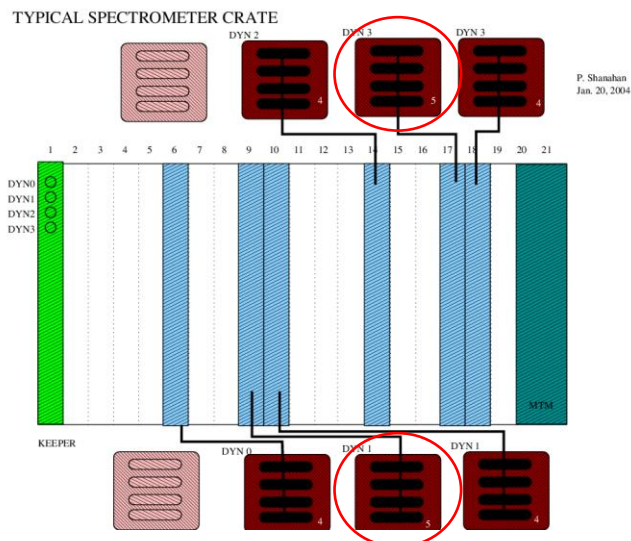
Bad (?) Alner box/PMT

Good Alner box/PMT

- Another faulty Alner box spare
- Optical fiber(s) or connections from detector to Alner box
- or the detector itself (unlikely)

- Moved a "good" Alner box from 0-20-5 (plane 141/151) to 0-20-1 (plane 121/131)
- Previously low rate channels 0-20-1 are now OK
- The problem was due to "bad" Alner box/ PMT
- A second spare is now in 0-20-5, which shows low rate: another bad spare?

- Retrieved a PMT from one CalDet Alner box to replace the one in the "bad" box
- Will test this repaired box in Lab G before putting back into detector
- Oxford will ship to us some PMT assemblies spares
